ELIMINATION OF PLASTIC MATERIAL POROSITY

Roman Pacht, MSc

*Technical University of Liberec, Czech Republic
Faculty of mechanical engineering, Department of engineering technology*

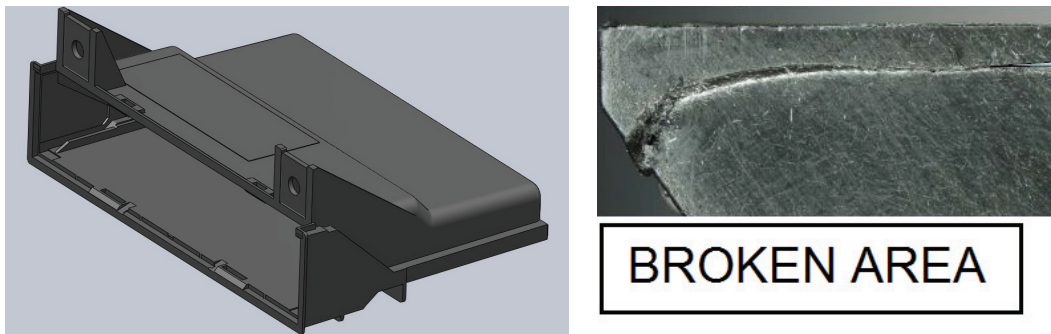
Figure 1 - Housing and detail of damage

A function of part is to hold an electronic device. During the life-time the part is exposed to cyclic straining. After tests the part was found to be broken in assembling area, near the screws which hold it. After that finding the parts were observed under loop to find a reason of the damage.

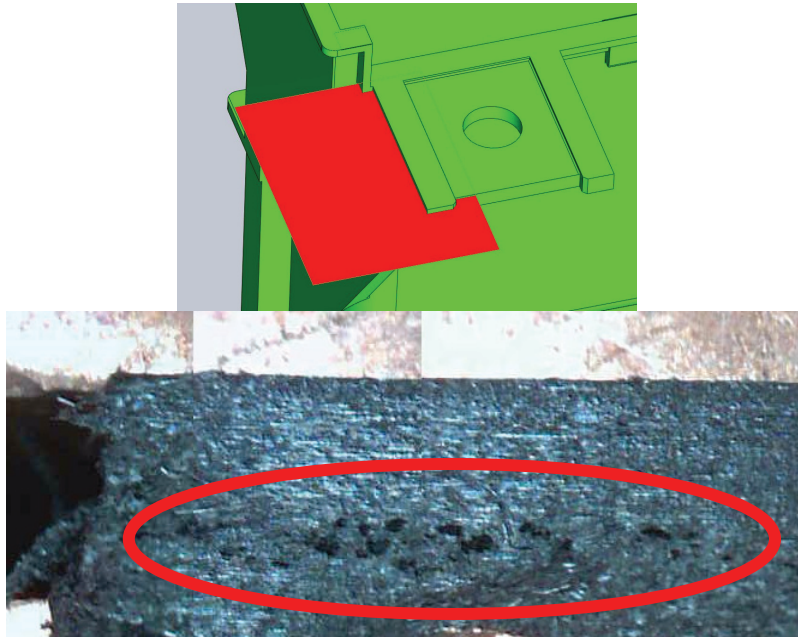
Microtome cuttings were used for this purpose. The microtome cutting technology is the way how to observe internal defects of plastic parts. Usually with a special knife the worker makes a strip of problematic area in tens of micrometer put it between two glasses and make snaps under microscope. The picture 2 captures a direction of cutting through part rib and mark able porosity of the part in this area. This porosity causes a damage of the part during a validation test. Gaps are in the area where two walls of part are in interaction. Wall thickness is here relatively similar and its value is 2 mm what is under recommended thickness. Material shrinkage has very different values in direction parallel to flow and across the flow. The glass fibers cause that fact. Cavities

appear along the edges where the glass fibers change their orientation for 90 degrees. Probably cause is then different shrinkage in this edge, residual stress and cavities creation. In combination with following cyclic dynamic load in car it has to lead to damage. In the next two captures we will look for possible solution.

Figure 2 - Cutting through the part rib

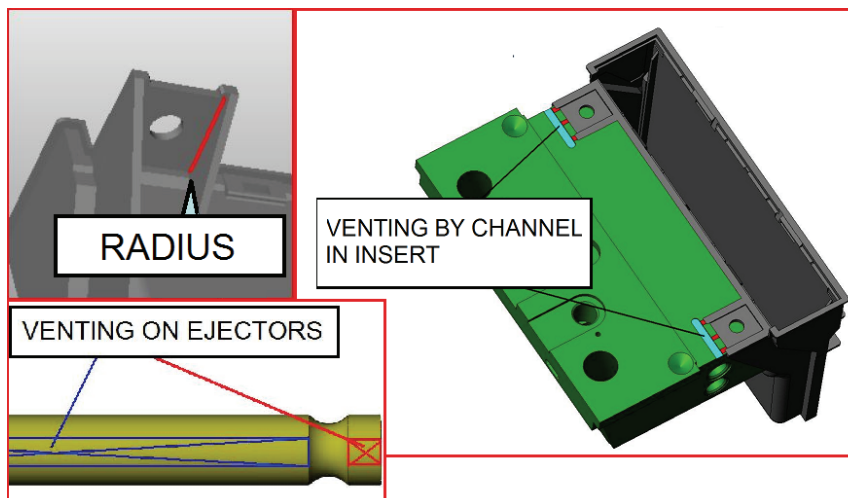
Tool modification is very expensive doing so it is every time a last step during optimization. As the first thing what is generally recommended when the porosity of material appears is to make a better venting of tool. The air which is easily going out can't make bubbles inside a plastic staff. The other step was making of radius in problematic area to eliminate a notch. The notch elimination helps to hold proper rigidity of part and decreases the effect of different shrinkage which is given by different orientation of glass fibers in this place.

Figure 3 - Tool modification

After this modification the rate of parts which have mark able porosity decreases to 10 %. This is better than the situation in the beginning, but has doesn't ensure 100 % function of the part. Our recommendation is to add ribs to stiffen problematic area. This will ensure function of the part without difficulties with new part design.
